# MIDWEST FLOODS of 2008 & IN IOWA & WISCONSIN

## 3 Residential, Historic, and Commercial Buildings

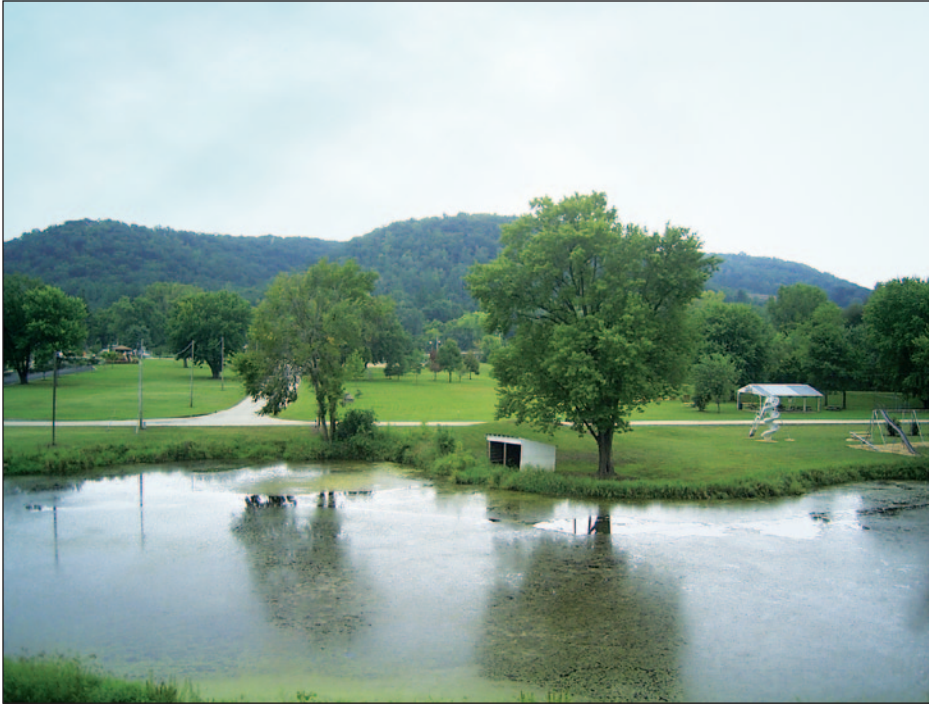
**Figure 3-87.** Upstream of Gays Mills along the Kickapoo River, this open space was once downtown Soldier's Grove before the community began relocating after significant flooding in 1978. In 2008, the park was inundated and repaired; however, the damages would have been much greater had the community not relocated (Soldiers Grove, Wisconsin).

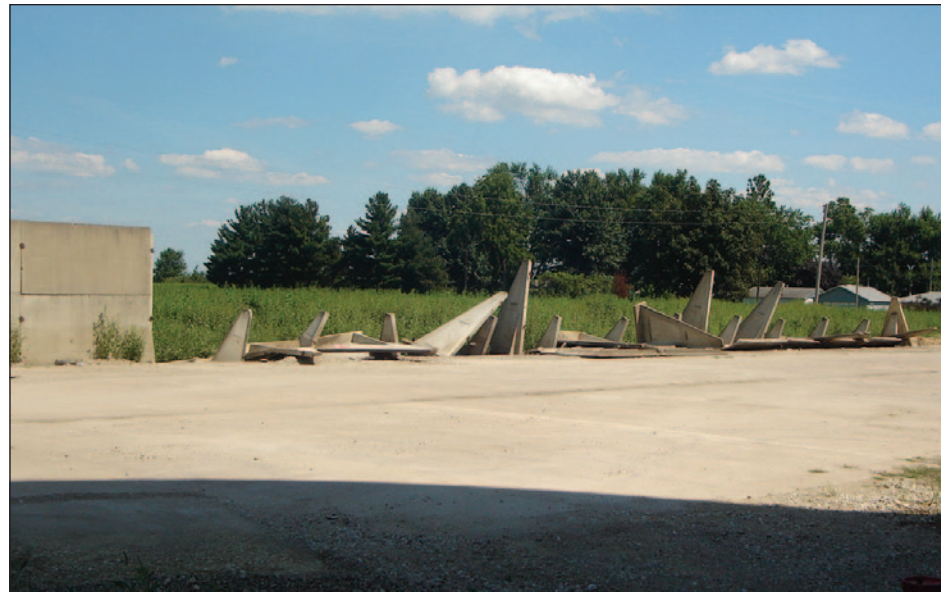
**Figure 3-89.**  
A dry-storage wall was destroyed at TriOak Foods (Oakville, Iowa).

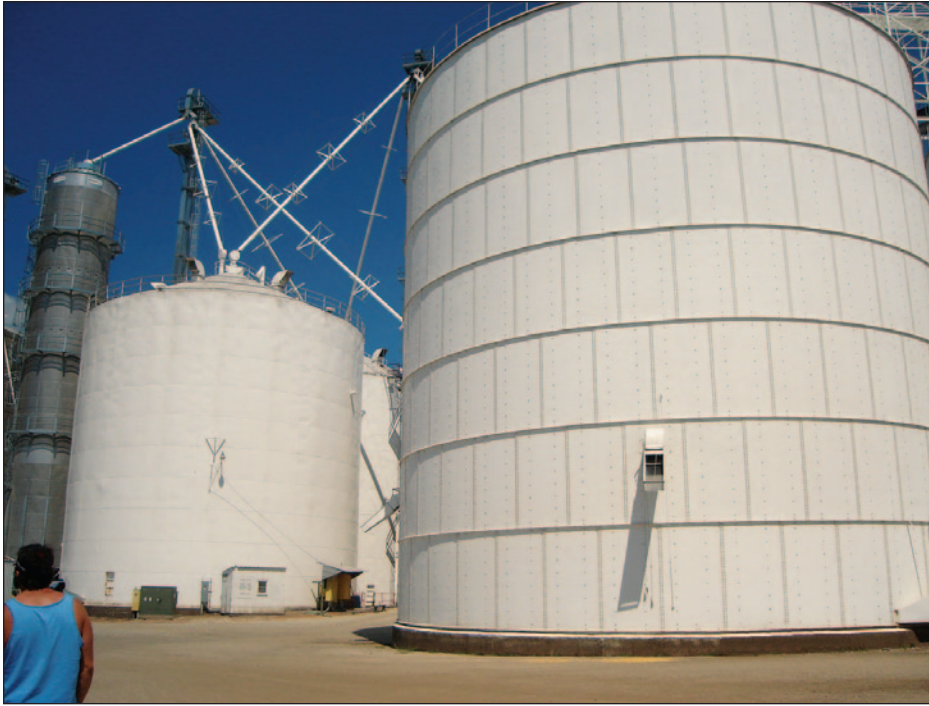
- Two underground, un-anchored, 10,000-gallon fuel tanks floated up from beneath a 4-inch concrete slab as shown in Figure 3-88. The Petroleum Equipment Institute publication *Recommended Practices for Installation of Underground Liquid Storage Systems* (RP100-05), which is cited in 40 CFR 280.20 (d) (ii), has recommended procedures for anchorage of these type tanks.
- Only pieces of a dry-storage wall remain upright; much of the wall was knocked over as shown in Figure 3-89.
- Metal feed silos constructed with bolted connections experienced some seepage resulting in damaged feed as shown in Figure 3-90. Welded feed silos did not have seepage issues.

Bolted silos like the one at right at TriOak Foods were prone to seepage; as a result, some feed was lost. Welded silos like the one at left did not experience seepage (Oakville, Iowa).

**Functional Loss:** Swine were evacuated during the flood. Although there was minimal damage to buildings, the plant remained closed for the duration of the flood and cleanup process. The damage to the fuel tanks could potentially lead to very expensive environmental cleanup efforts. Anchoring of any above or underground fuel tanks is recommended as well as placement and anchoring of above ground tanks in secondary retention structures.

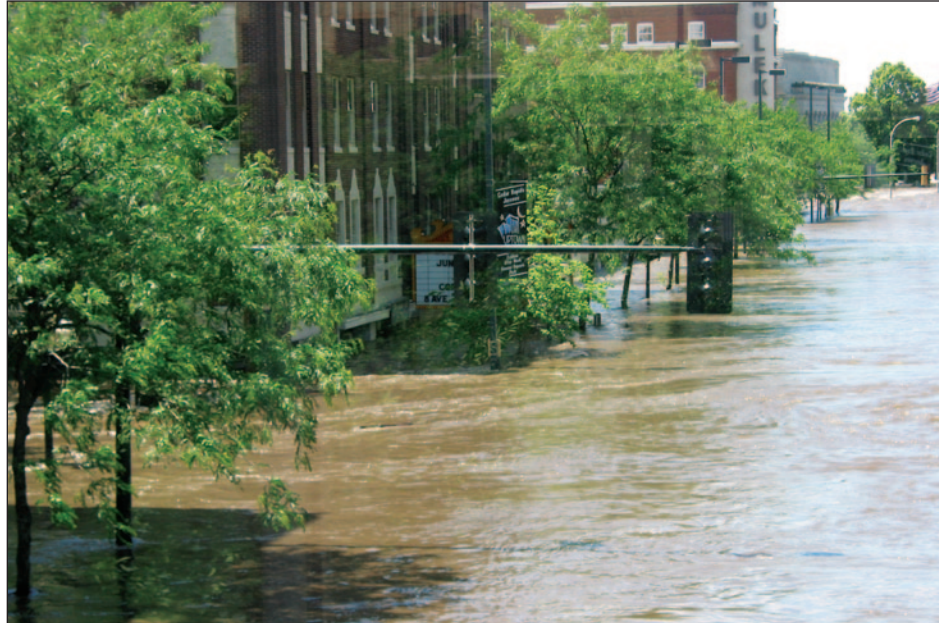
**Summary of Damages:** According to residents, the Cedar River inundated 1,300 blocks and 9.2 square miles of the city on both sides of its banks. Flooding affected the commercial, municipal, and industrial districts, among others. Throughout the downtown area, water depths of 7 to 8 feet were observed.

Most buildings experienced significant flooding in their basements and first floors, resulting in severe damage to interior architectural finishes and contents. Few structural failures were observed.

**Figure 3-91.**  
The Cedar Rapids downtown district had up to 8 feet of water at the height of the flood (Cedar Rapids, Iowa).

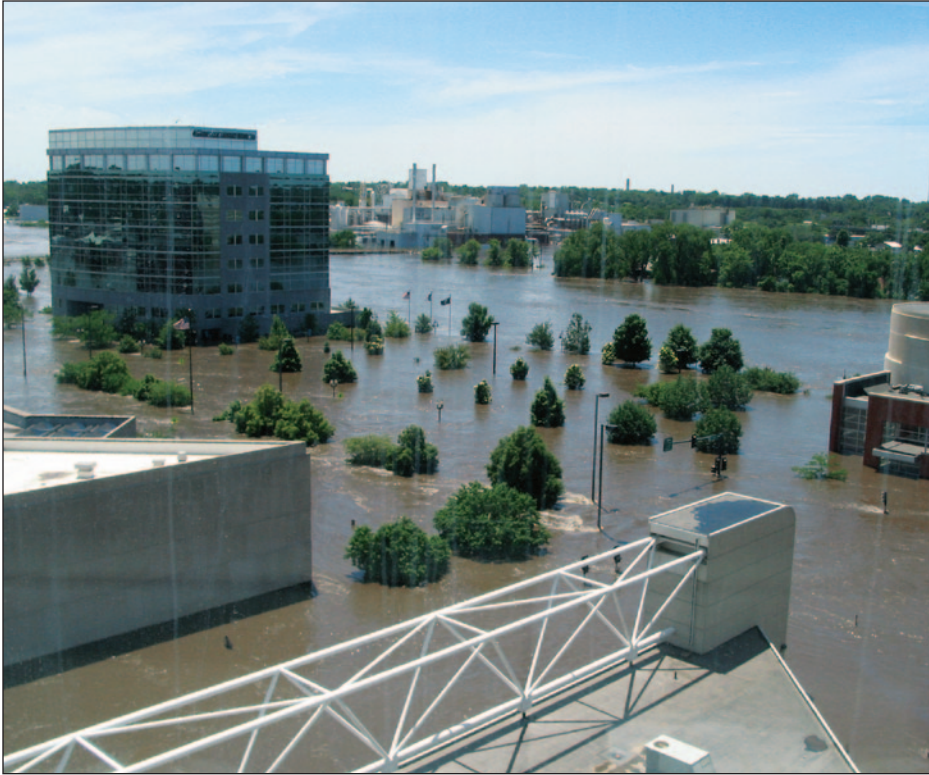
**Figure 3-92.**

**Summary of Damages:** The slab-on-grade structure had 7.5 feet of water on the first floor, which resulted in an estimated \$2 million in damages to interior finishes and utilities, including electrical equipment and wiring, fire pumps, and the emergency generator. The only damage to upper level offices was due to one office's equipment malfunctioning when power was shut off—that damage was minimal. This office building plans to restore all damaged equipment to its pre-flood location.

The Great American Building sits along the Cedar River. Although it had a flood response plan in place, it experienced significant flooding on its ground floor. This property, in an A11 flood zone, has a BFE of 724 feet, and an elevation of approximately 720 feet (Cedar Rapids, Iowa).
